Town of Bath, West Virginia

Sidewalk Self-Evaluation for ADA Accessibility

Prepared for the Streetscape Committee by
Peter Brown and Barbara Zimmerman

August 2017

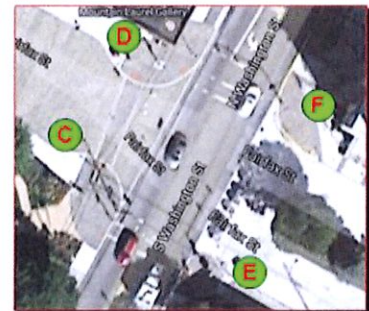
Washington at Fairfax

Example of Intersection designed for ADA compliant crosswalks and corner ramps at all four sides. Installed in various Streetscapes Phases

The only marked crosswalk is from C to D-2; but while curb and street are level at C, there is no DWS or ADA compliant ramp at C and no DWS at D-2

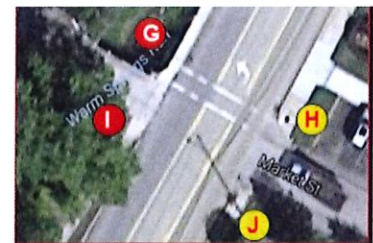
So. Washington at Market

There is 1 marked crosswalk at this intersection. The existing ramps do not meet ADA dimensions and there are no DWS warnings

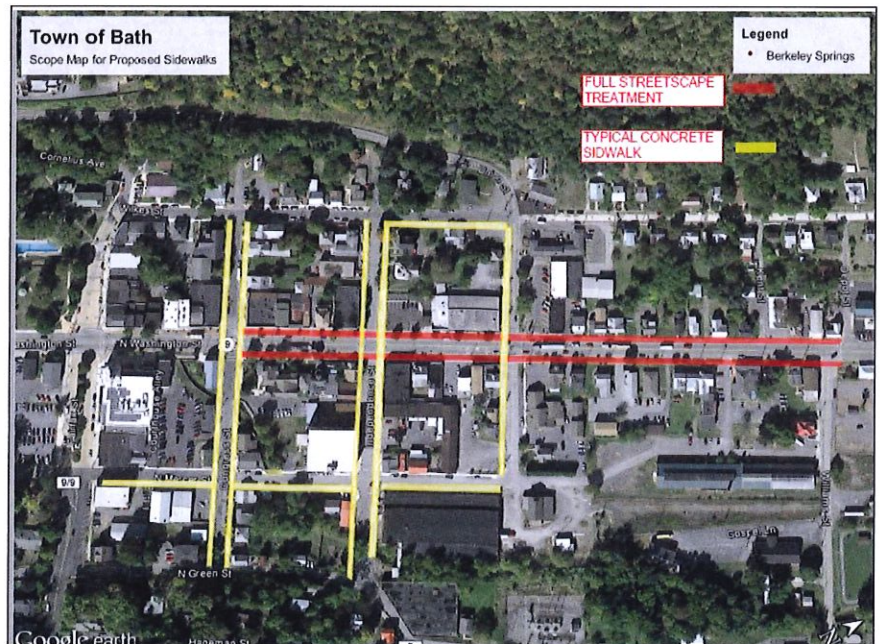
Figure (1)

Streetscapes Committee Projects have been completed through Phase III. In each Phase, the detailed design provided by the engineering organization considered both the existing condition of sidewalks/crossings and the various guidelines and standards (such as ADA criteria) called-for by the State of West Virginia. The Town is in the early design stages of Phase IV of the Projects. The area of the Town included in Phase IV reflects the basic “Six-Block” strategy, and extends the area of consideration along Washington St all the way north to Williams St. It also includes the south side of Fairfax St between Washington St and Mercer St. Figure 1 shows the planned Phase IV area.

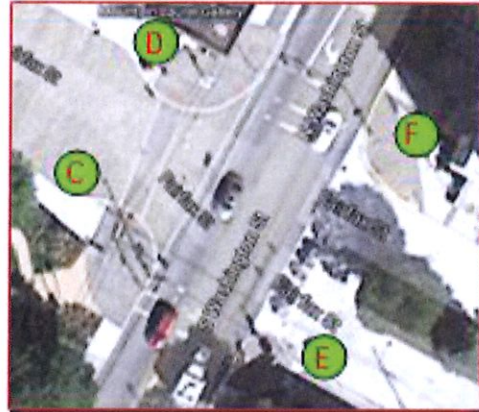
Washington at Fairfax

Example of Intersection designed for ADA compliant crosswalks and corner ramps at all four sides. Installed in various Streetscapes Phases

The only marked crosswalk is from C to D-2; but while curb and street are level at C; there is no DWS or ADA compliant ramp at C and no DWS at D-2

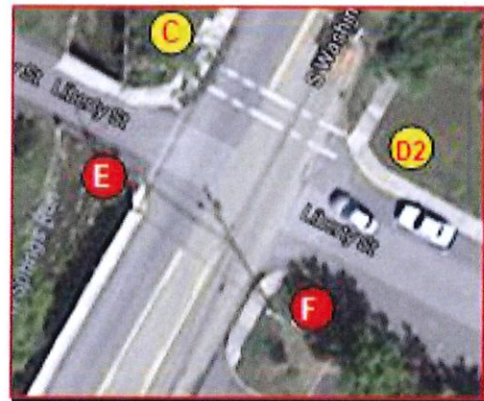
So. Washington at Liberty

Example of Crosswalk with corner modifications to improve accessibility, but not fully ADA compliant

There is 1 marked crosswalk at this intersection. The existing ramps do not meet ADA dimensions and there are no DWS warnings

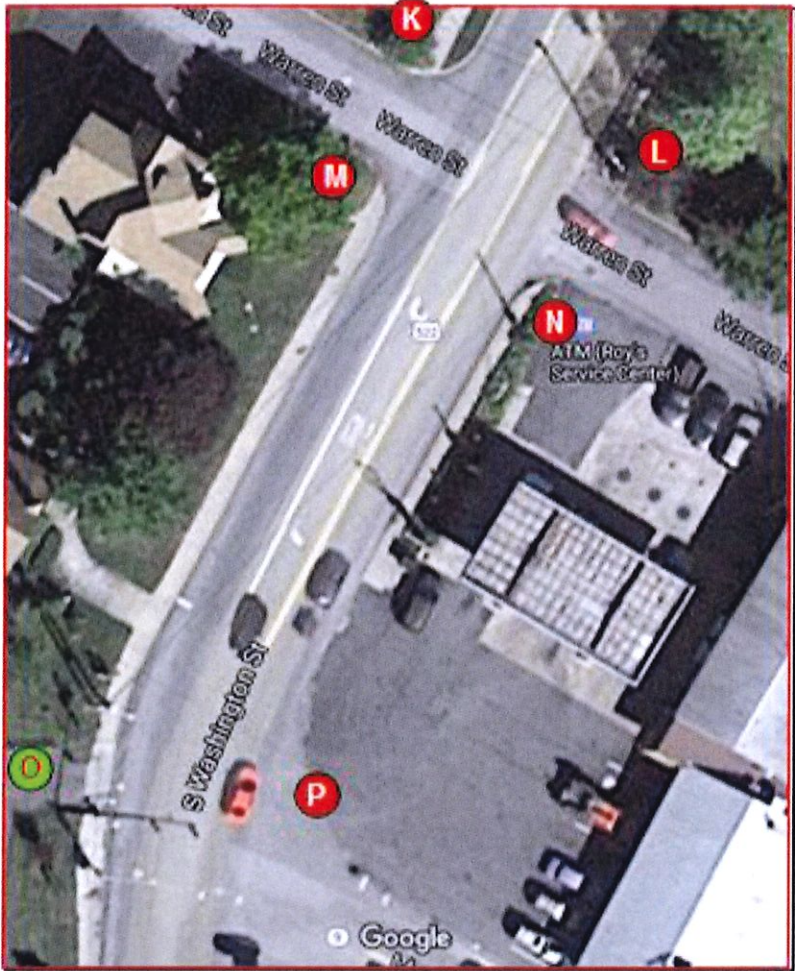
**So. Washington at
Warren &
Martinsburg Rd**

There are no marked crosswalks at these two intersections. There are no ramps.

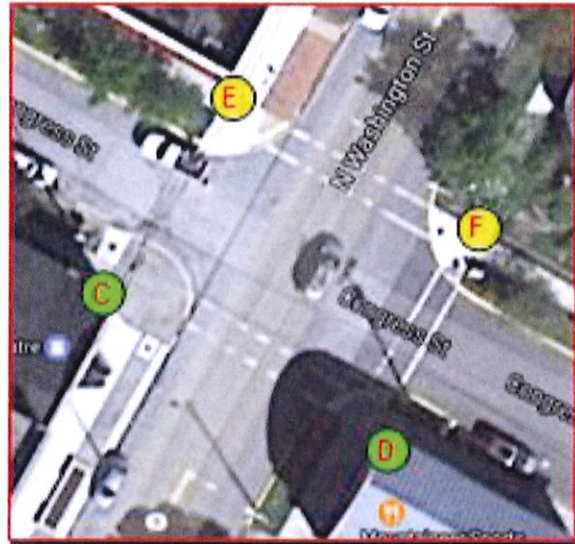
No. Washington at Congress

There is a crosswalk from E to F but no ADA compliant ramps or landings are aligned with this crosswalk

Example of Intersection designed for ADA compliant crosswalks and ramps at three of four sides: C-E; C-D; D-F; but not E-F

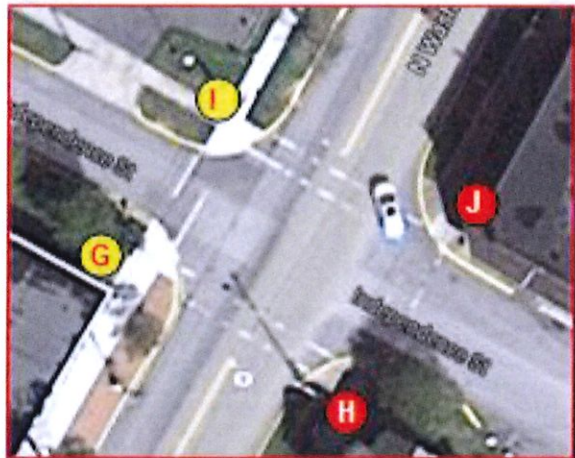
No. Washington at Independence

Example of Intersection with several designs for ADA compliant crosswalks and ramps at all four sides. Corners I & G have DWS and are aligned toward the turn apex.

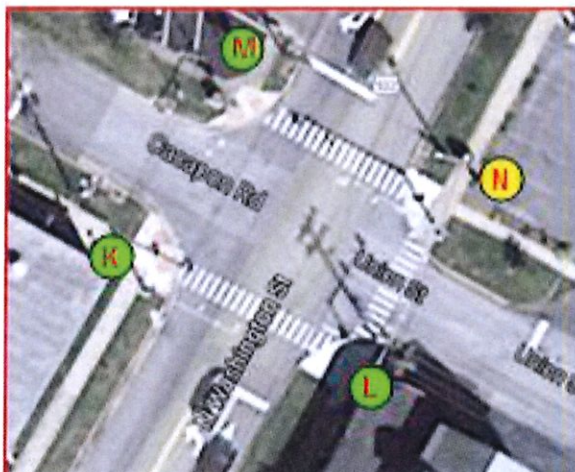
No. Washington at Union

Example of Intersection with several designs for ADA compliant crosswalks and ramps at all four sides. Corner N has no DWS.

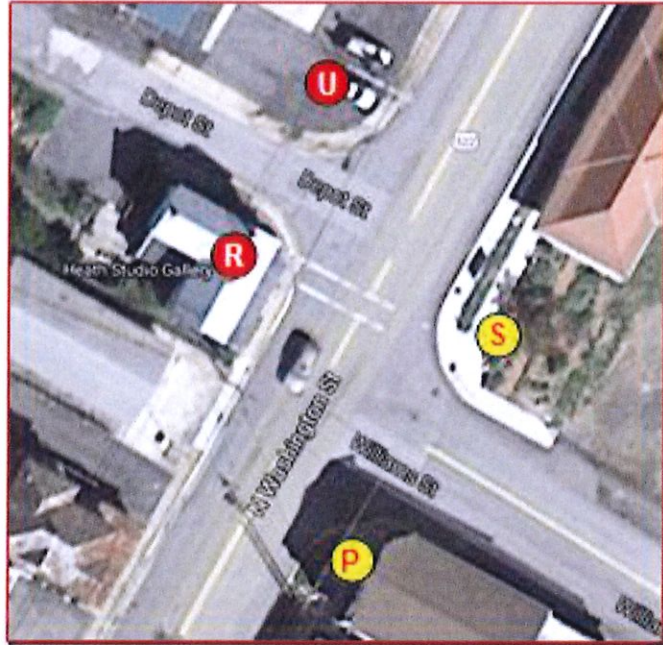
No. Washington at Depot & Williams

Example of Intersection modified for 3 crosswalks; but only 1 is painted. Corner R has a minimal ramp below ADA standards and no DWS. Corners P and S have ramps but no DWS. Corner U has a minimal ramp to cross Depot St only and no DWS.

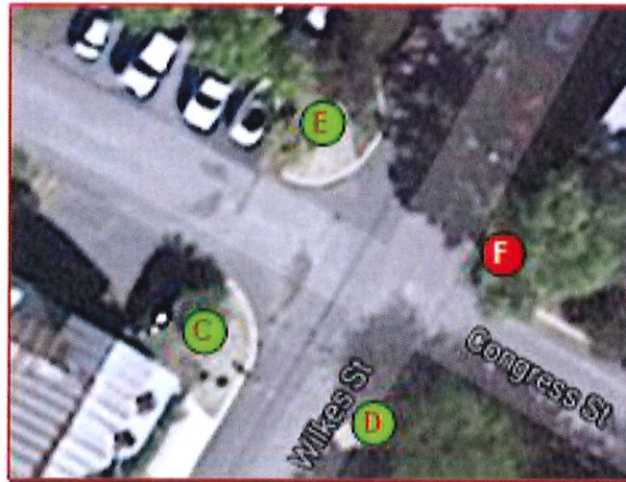
Wilkes St at Congress St

Example of Intersection designed for ADA compliant crosswalks and ramps at three of four sides: C-E; C-D; D-F; but not E-F. The "Ramp" at "F" is level with street; but no DWS.

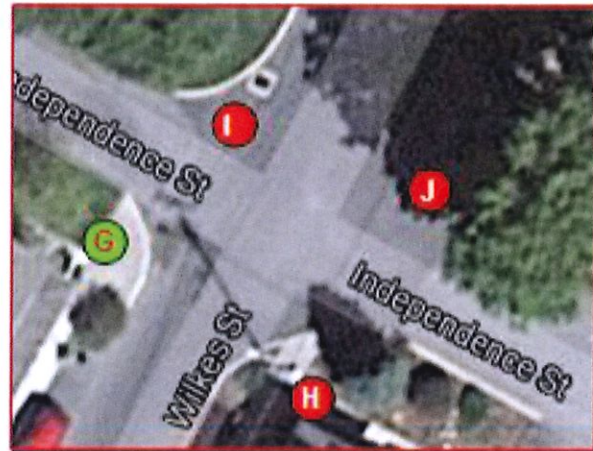
Wilkes St at Independence St

Example of Intersection designed with only (1) ADA compliant Corner with Ramp and DWS; no marked crosswalks and incomplete corner treatments at "J" (gravel) or "H" (corner is at curb height).

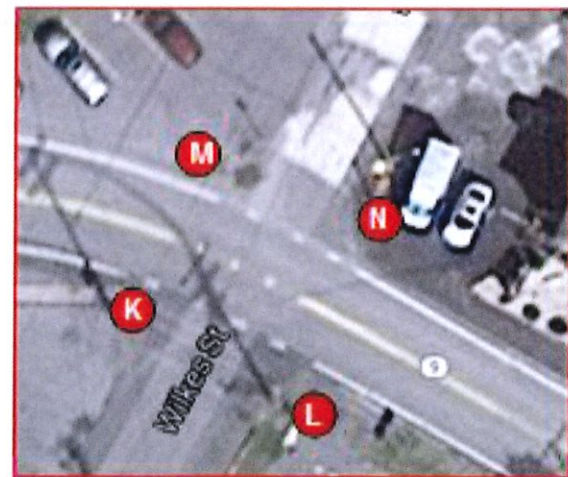
Wilkes St at Union St

Example of an "open" intersection. There are no marked crosswalks and no corner treatments or ramps. Corners of intersection are marked by power poles and street signs. Corner "L" is at the intersection of two sidewalks (Wilkes and Union) but these are incomplete and do not reach Corner "L".

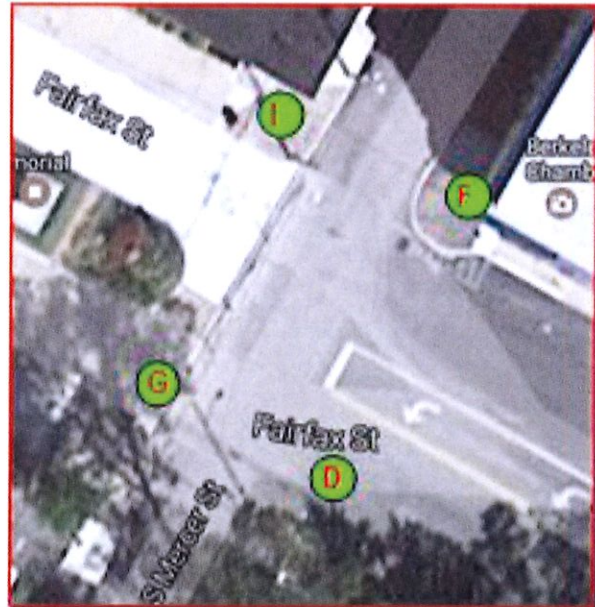
Mercer St at Fairfax St

Example of Intersection designed for ADA compliant crosswalks, ramps and DWS at all four sides.

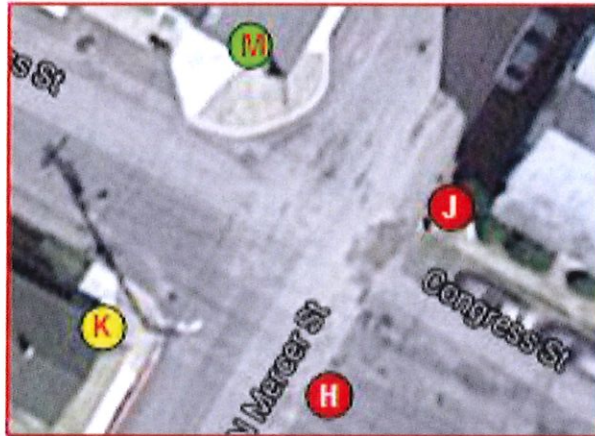
Mercer St at Congress St

Example of Intersection designed with limited ADA compliant Corners with Ramp and DWS. Corners "K" & "M" are recent ADA designs, but "K" is only 1-way (cross Congress) with power pole obstruction and "M" provides proper apex access. There is no matching ramp across at "J". Corner "H" is a parking lot level with streets.

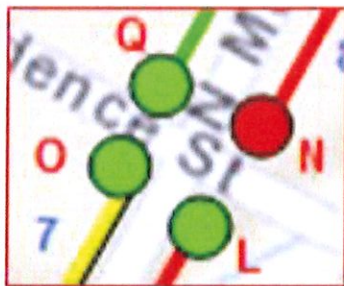
Mercer St at Independence St

Corner ramps are generally the "apex" design that can assist in crossing either street. There are no adjacent sidewalks attached to Corner "L". There is no corner treatment nor sidewalks attached to Corner "N".

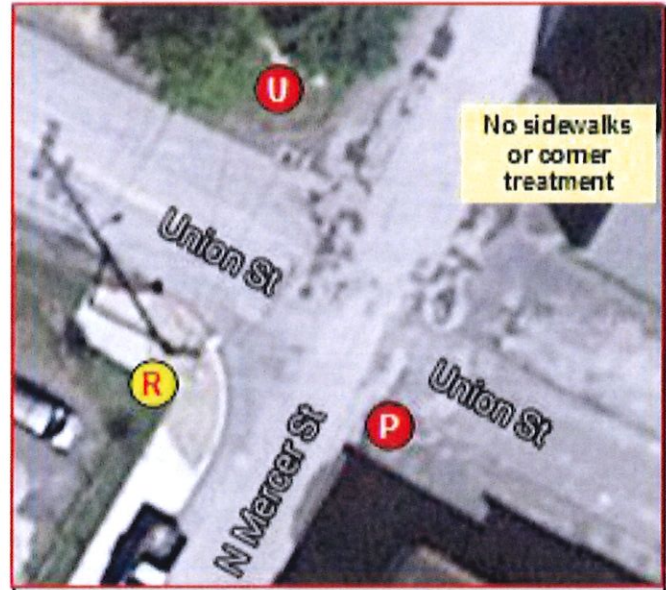
Mercer St at Union St

There is (1) nearly compliant corner (R). It is an apex ramp, but has obstructions due to a power pole and Stop Sign. Corner "U" has a sidewalk that ends in a grass patch – with no street access. There are no sidewalks or corner treatments at "P".

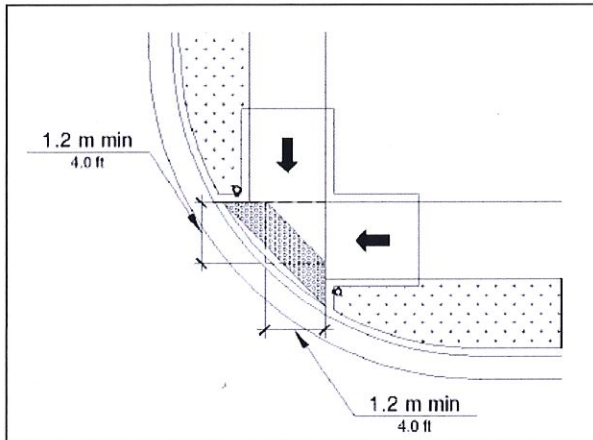
Single Ramp that serves two streets

1. Continue to optimize choices for the corner designs at intersections. For example; choosing single/apex ramps or double/two-way ramps based on specific streets and traffic.

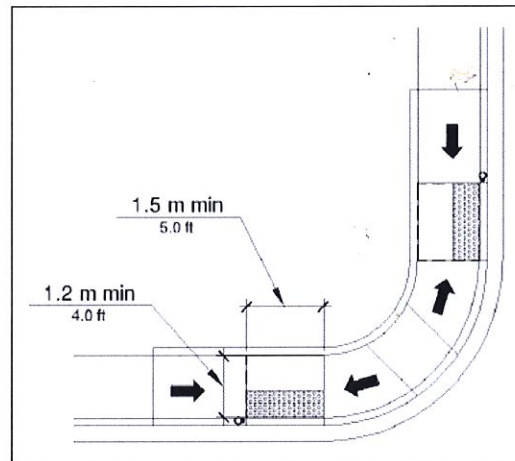
Double Ramps aligned with each street
