South Washington Street - TOWN OF BATH SIDEWALK EVALUATION

Street: South Washington St (Fairfax to Martinsburg Rd (Rte-9))

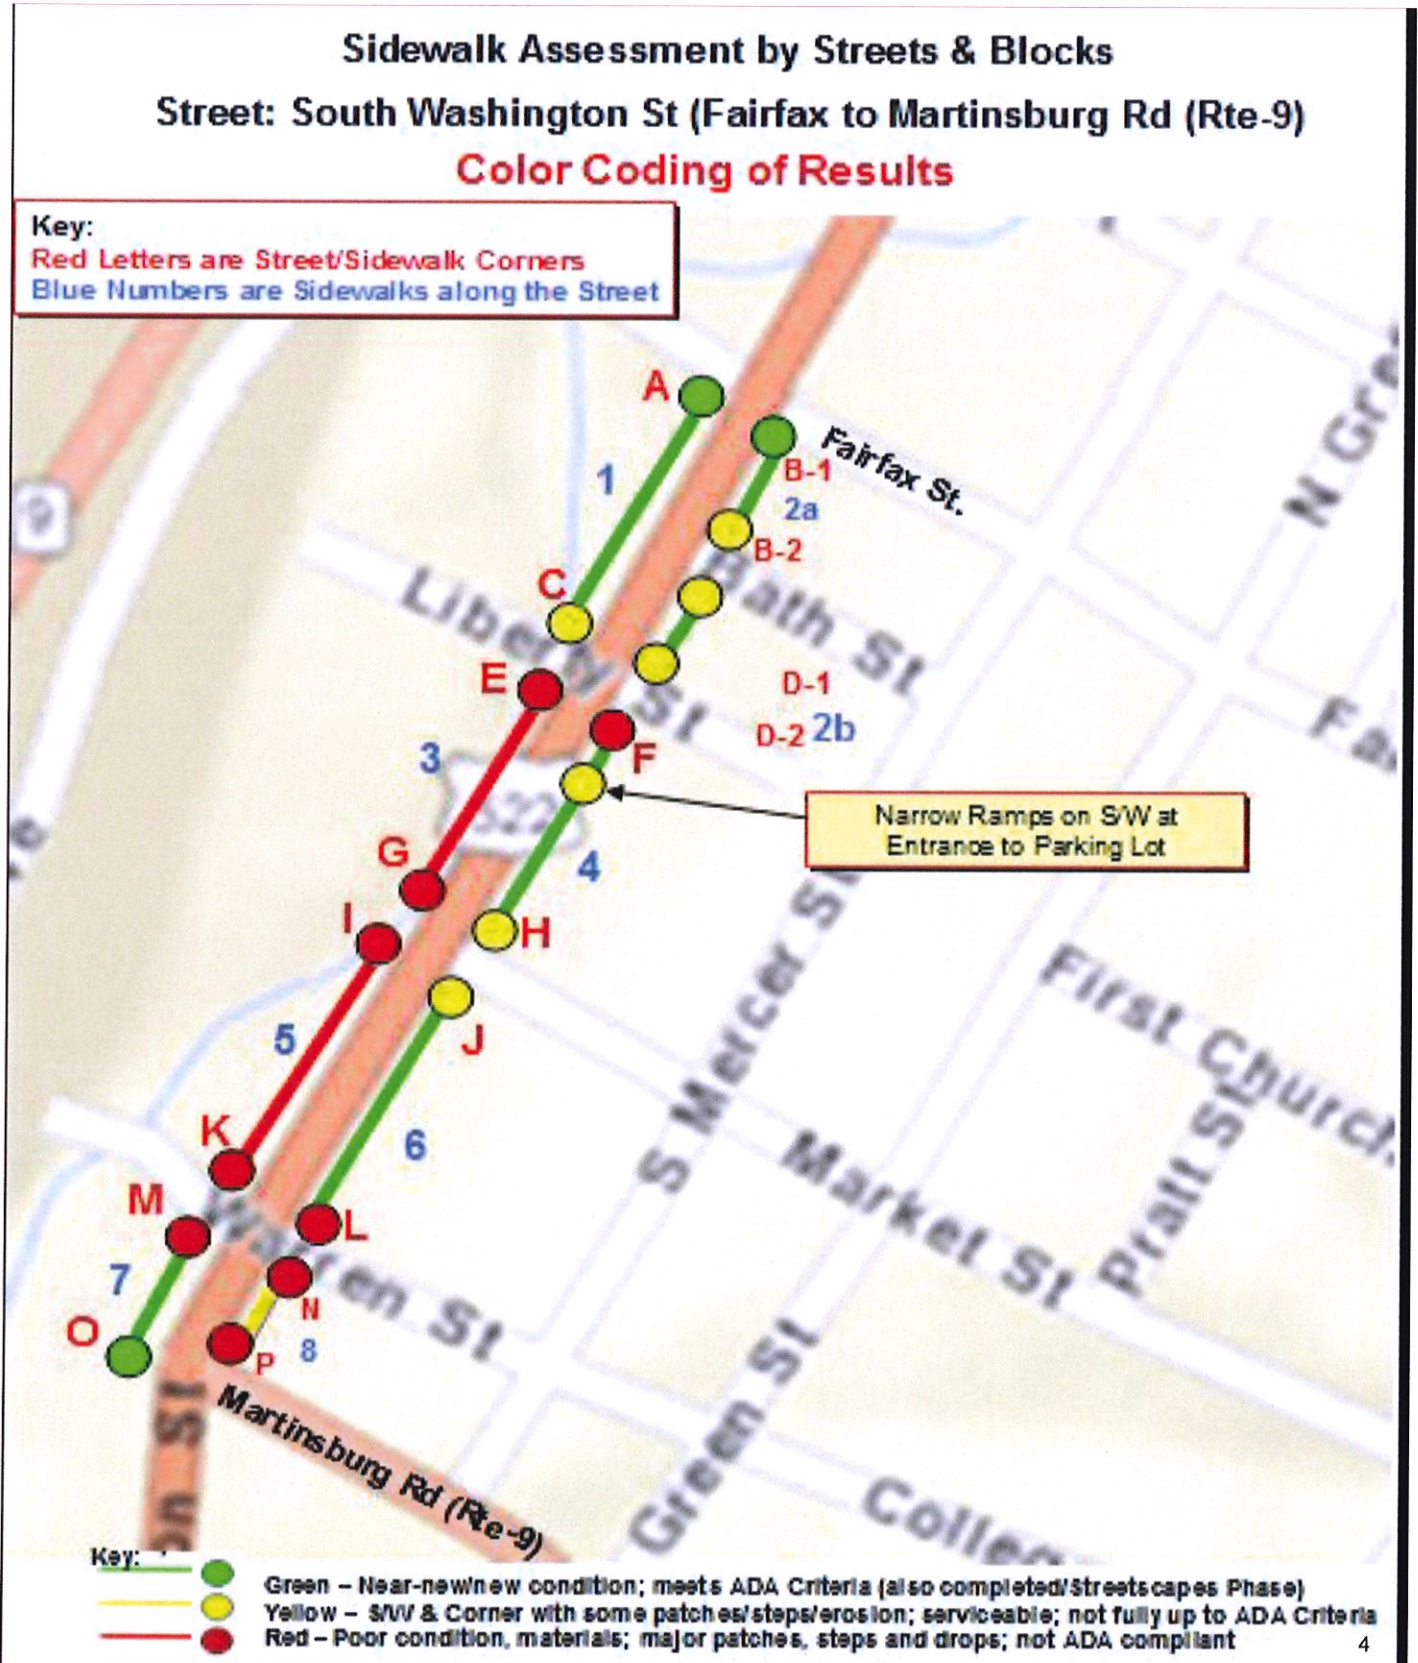
Color Coding of Results

A	G	New 2-way Ramps - done in Phase 3	Yes	Ramps; materials and Detectable Warning System intact; Adjacent Traffic light/crossing system appears to be ADA compliant
South Washington	1		G	Appears that S/W surface has been "blasted" or otherwise treated to make it rougher; otherwise OK	Yes	
		C	Y	Sidewalk & driveway to Park are essentially level - no ramp present	Partial	There is no Detectable Warning System (DWS) at this corner
		B-1	G	New 2-way Ramps - done in Phase 3	Yes	Ramps; materials and Detectable Warning System intact; Adjacent Traffic light/crossing system appears to be ADA compliant
South Washington	2a		G	Wide sidewalk; Good to Fair surface	Yes	Some small "steps" between sections
		B-2	Y	Narrow Ramp (3.5 ft)	Partial	No DWS at ramp
		D-1	Y	Sidewalk is essentially level with the street crossing	Partial	No ADA features at this corner; no DWS
South Washington	2b		G	Fair to good surface.		Some small "steps" between sections

D-2	Y	Narrow Ramp (xxx? ft)	Partial	No DWS at ramp
		E	R	No Ramp present & S/W is only 3 ft wide to Fence	No	Estimate S/W not useable for ADA since only one end has access via level drive & S/W
South Washington	3		R	S/W is only 3 ft wide to Fence	No	Possible ADA access at only One End; no DWS at either end
		G	R	Slight access since drive & S/W are almost level	No	No DWS; possible "trap" since there is no Ramp at other end of section "3"
		F	R	Narrow Ramp (3 ft)	Partial	No DWS at ramp
South Washington	4		G	Fair to good surface - some small steps	Yes

(2) Ramps to CNB Driveway	Y	S/W Ramps to CNB Parking Lot - narrow but in-line with S/W	Partial	No DWS at ramps
		H	Y	Wider Ramp almost 4 ft	Partial	No DWS at ramp
		I	R	S/W is level with street area; but no ramp or DWS	No	No DWS
South Washington	5		R	S/W is lower than street; prone to flooding and dirt build-up; eroded, cracked & broken	No	S/W not always level and sometimes pitched; poor condition
		K	R	No Ramp	No	No DWS
