WILLIAMS STREET - TOWN OF BATH SIDEWALK EVALUATION

PHOTOS OF SPECIFIC AREAS

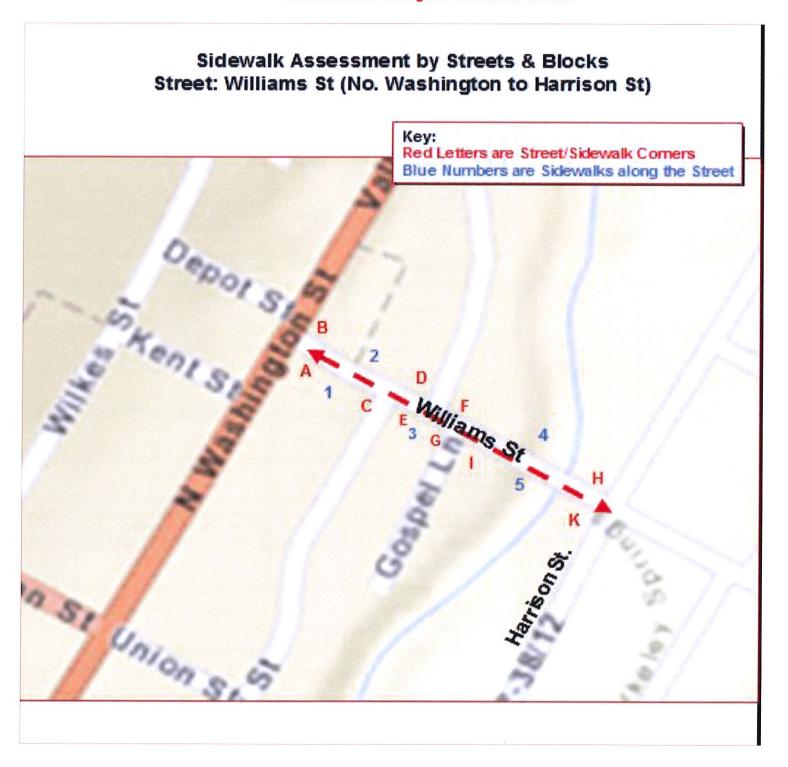
Identification & Coding of Sidewalks & Corners

Street	Sidewalk Map No.	Corner Map Letter	Code	Condition Found (Missing Sections; warped; steps/drops; patches; <4 ft wide)	Complies w/ADA Stds?	Notes
	1, 2, 3 etc	A, B, C etc	G-Y-R	MS-W-S/D-P-<4'	Ramps/Material	Status in Streetscapes Plans
		Α	Υ	Older one way ADA ramp across Williams; no DWS	Partial	Review for Phase IV work. No crosswalk across No. Washington at this point - ramp aligned to cross Williams only; no DWS
Williams	1		Υ	Older sidewalk, some pitting on surface	Partial	
		С	Υ	Sidewalk is in fair shape. It slopes until it is at grade with the adjoining pavement	Partial	
		В	Y	There is a one-way ramp to cross Williams but no DWS texture. No Ramp to cross No. Washington	Partial	Review for work in Phase IV
Williams	2		Υ	There is new sidewalk extending approximately 8' along Williams that terminates in a DWS that is blocked by a pole	Partial	Pole for the town lot fence is located in the center of the DWS. The short sidewalk is OK, but not long enough & its ramp ends in a pole.

D	R	Sidewalk does not extend to a logical end-of-block corner	No	Dangerous conflicts between town lot, tractor trailer parking and pedestrians
		E	R	No improvements	No	
Williams	3		R	No improvements	No	
		G	R	No improvements	No	
		F	R	No improvements	No	
Williams	4		R	No improvements except a wooden pedestrian bridge across the run	No	
		Н	R	Cracked and broken sidewalk wraps around Harrision on to Williams	No	Sidewalk extension from Harrision is even with the pavement and in poor condition
		Ĺ	R	No improvements	No	
Williams	5		R	No improvements	No	Dangerous area for pedestrians
		К	R	No improvements	No	Dangerous area for pedestrians
	9
