LIBERTY ST - TOWN OF BATH SIDEWALK EVALUATION

Sidewalk Assessment by Streets & Blocks

Street: Liberty St (End to End)

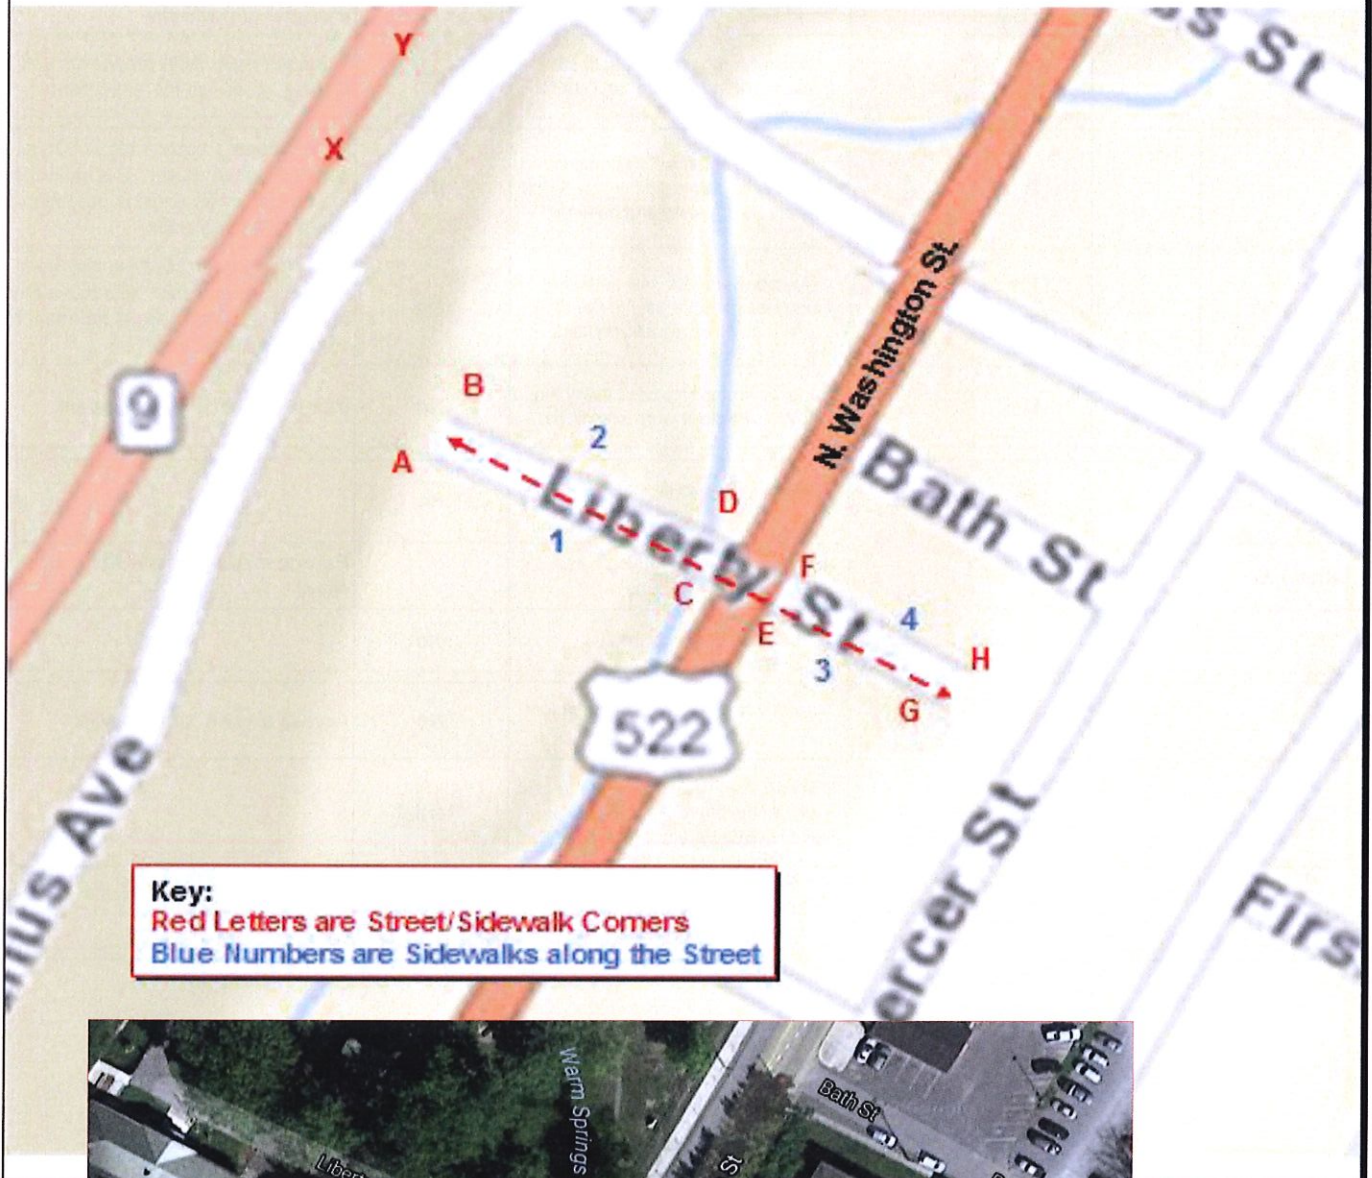
Identification & Coding of Sidewalks & Corners

Key:
Red Letters are Street/Sidewalk Corners
Blue Numbers are Sidewalks along the Street

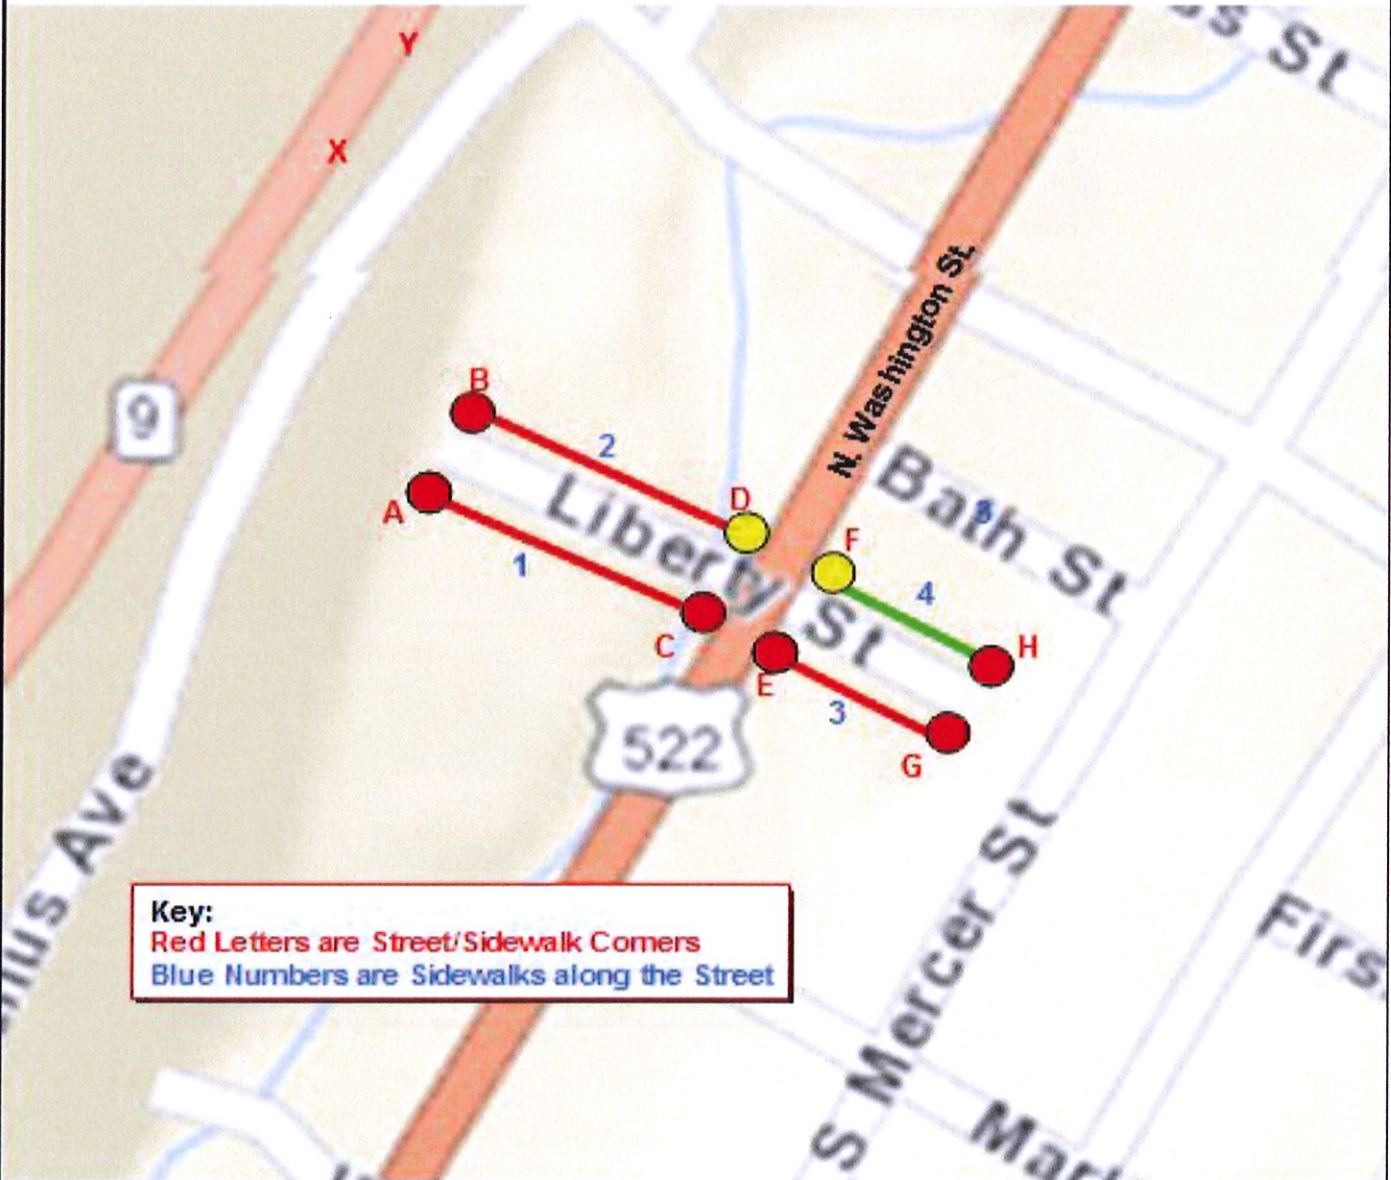
Color Coding of Results

- Key: *
- Green – Near-new/new condition; meets ADA Criteria (also completed Streetscapes Phase)
 - Yellow – S/W & Corner with some patches/steps/erosion; serviceable; not fully up to ADA Criteria
 - Red – Poor condition, materials; major patches, steps and drops; not ADA compliant
