MARTINSBURG ROAD - TOWN OF BATH SIDEWALK EVALUATION

Martinsburg Rd (So. Washington to Coffee Shop)

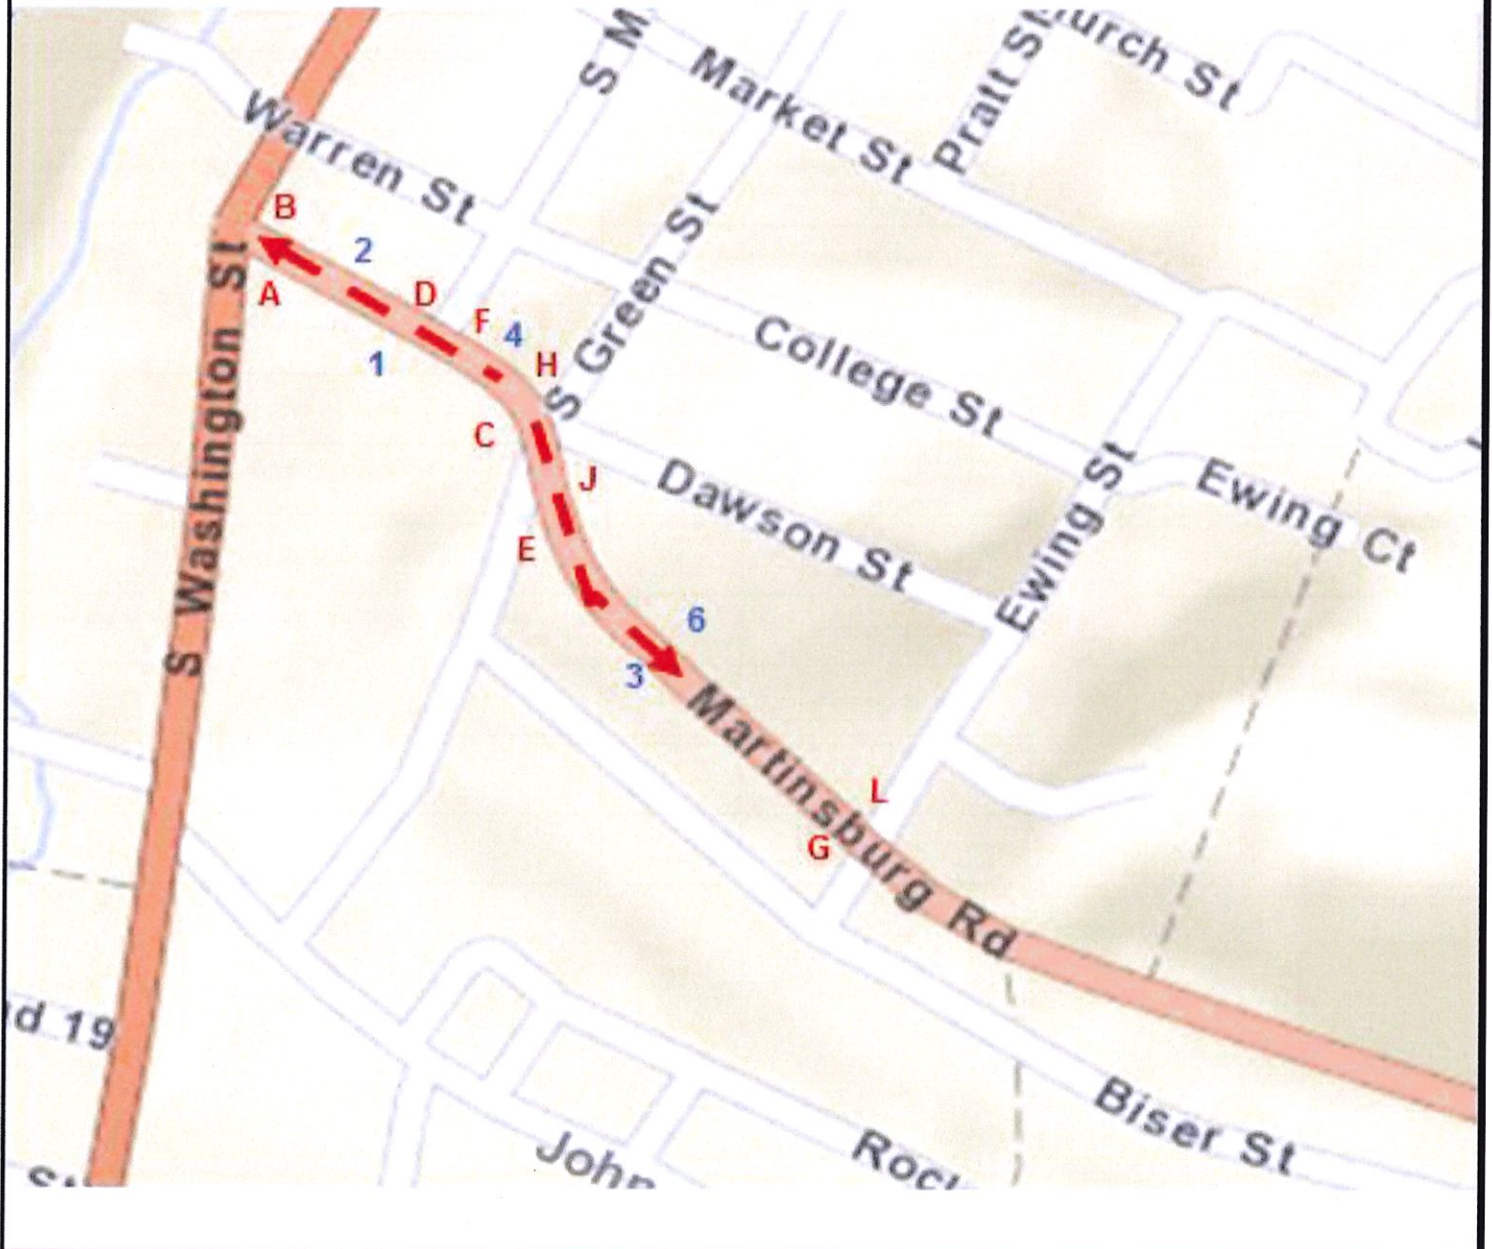
Identification & Coding of Sidewalks & Corners

Key:
Red Letters are Street/Sidewalk Corners
Blue Numbers are Sidewalks along the Street

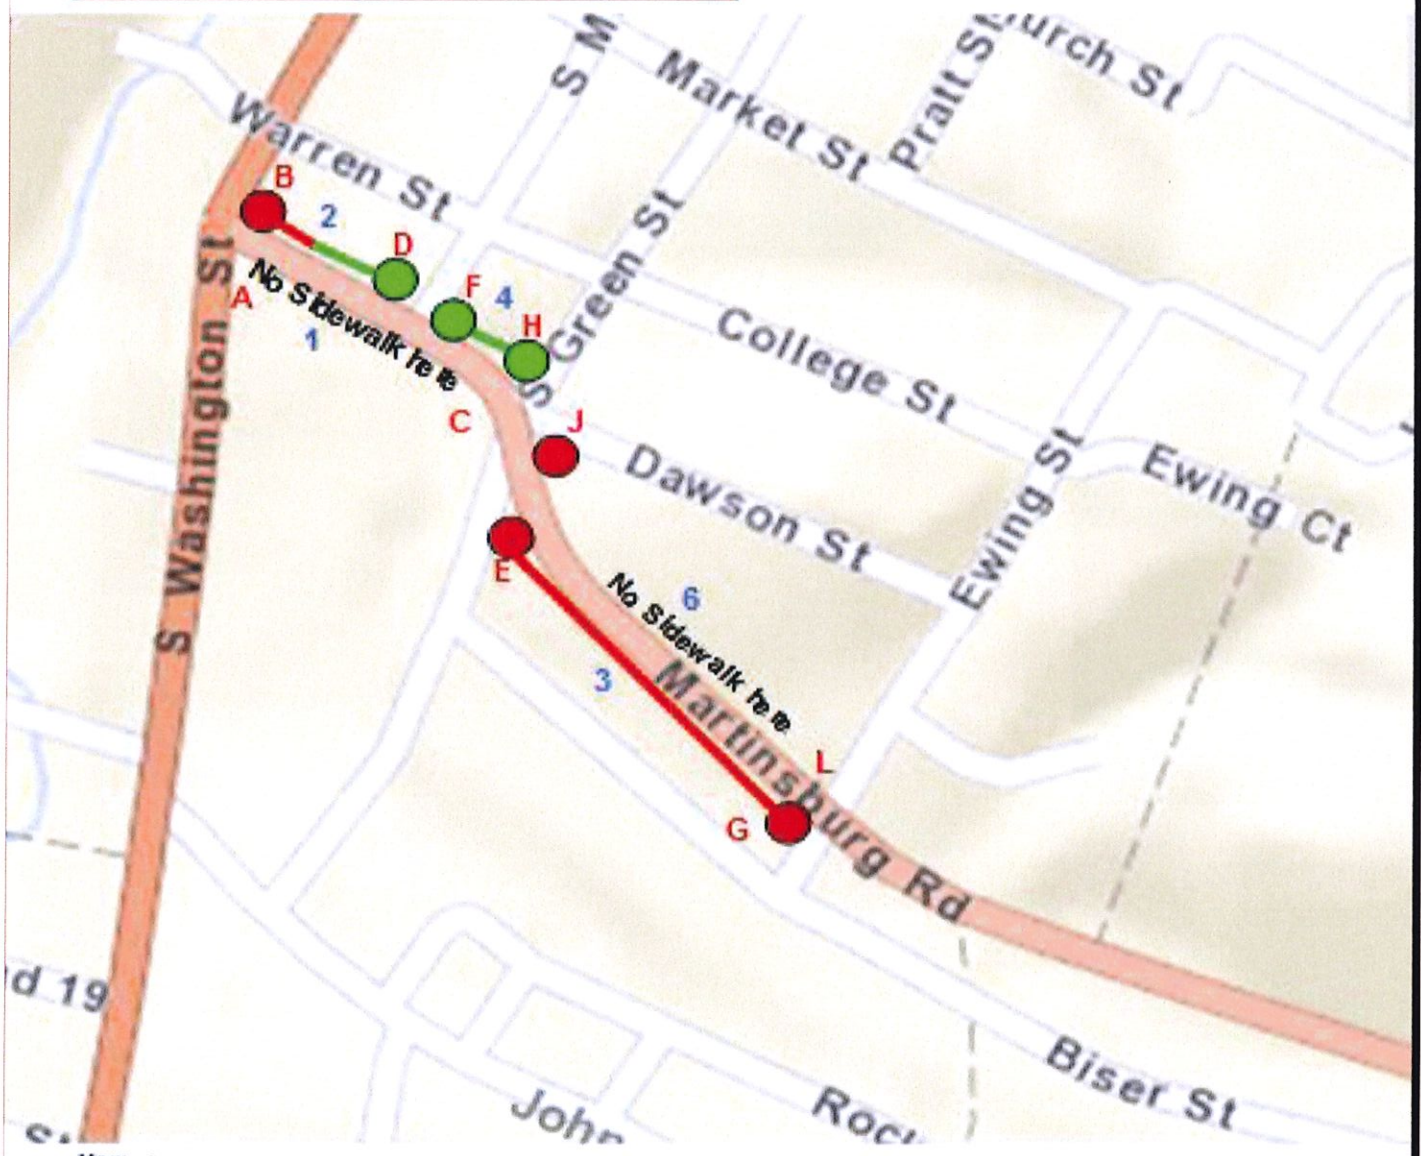
Color Coding of Results

Key:

- Green - Near-new/new condition; meets ADA Criteria (also completed/streetscapes Phase)
- Yellow - S/V & Corner with some patches/steps/erosion; serviceable; not fully up to ADA Criteria
- Red - Poor condition, materials; major patches, steps and drops; not ADA compliant

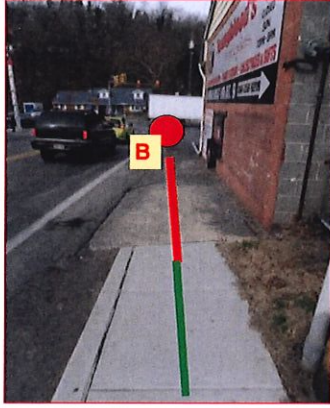
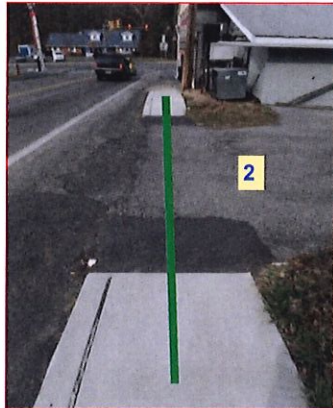
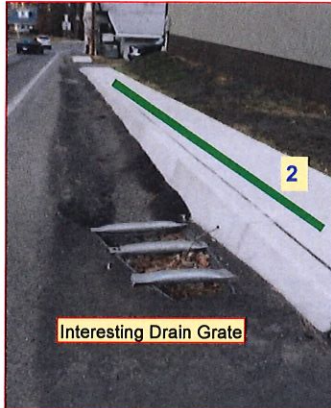
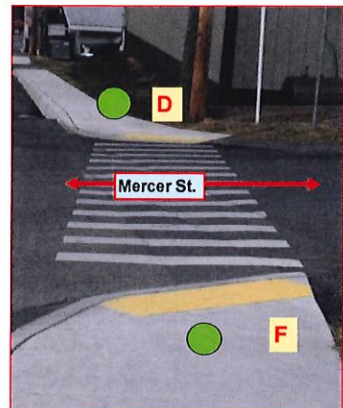
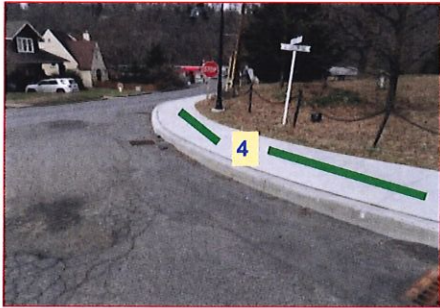
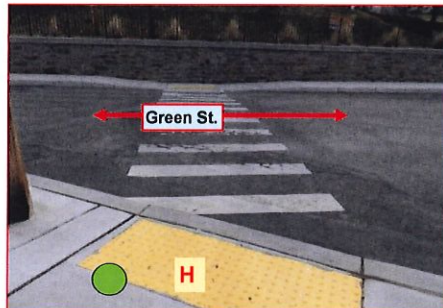
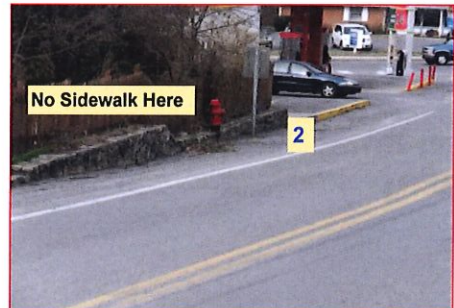
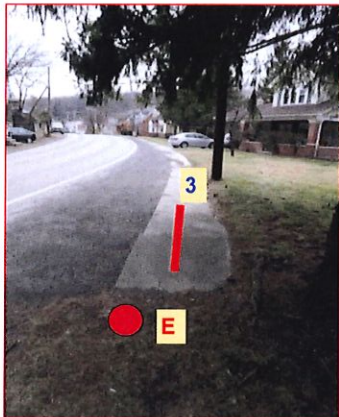
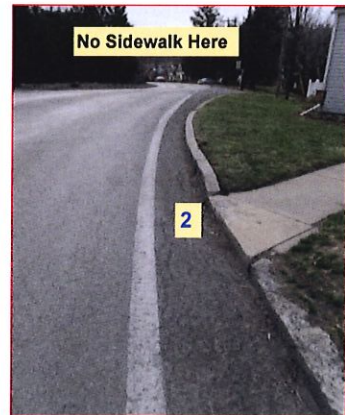
PHOTOS OF SPECIFIC AREAS

Street	Sidewalk Map No.	Corner Map Letter	Evaluated Condition Code	Condition Found (Missing Sections; warped; steps/drops; patches; <4 ft wide)	Complies w/ADA Stds?	Notes
	1, 2, 3 etc	A, B, C etc	G-Y-R	MS-W/S/D-P-<4'	Ramps/Material	Status in Streetscapes Plans
		A	R	Curb drops off from height of 4-5 inches	No	Conflict with vehicles ingress/egress to Sheetz
Martinsburg Rd	1		R	No sidewalk. Dangerous for pedestrians	No	This Block has no sidewalk and only a narrow shoulder from the roadway
		C	R	No improvements	No	
		B	R	No improvements. Service station paving goes from corner to corner.	No	Conflict with vehicles ingress/egress to Roy's
Martinsburg Rd	2		Y	First half is poor, but the second half has been recently improved to Mercer St	Partial	First half is red. Second half is green
		D	G	One way access across Mercer with DWS	Yes	
		E	R	No improvements	No	
Martinsburg Rd	3		R	4' sidewalk cracked and uneven. Gravel needs to be removed. Residents park on sidewalk and shoulder.	No	A small portion near the east end is in good shape but deadends into a power pole

G	R	No improvements	No	
		F	G	One way access across Mercer with DWS	Yes	
Martinsburg Rd	4		G	New sidewalk	Yes	
		H	G	Sidewalk wraps around to Green St and provides accessible crossing there.	Yes	While there is good access across Green St, there is no access across Martinsburg Road
		J	R	The new sidewalk has a paved ramp onto Dawson St.	No	This is a dangerous crossing for pedestrians
Martinsburg Rd	6		R	No improvements	No	Parking along Martinsburg Rd conflicts with any pedestrian use on the north side of street
		L	R	No improvements	No
