Streets/Sidewalks Proposed for Improvement in Phase VI Completed and Planned for Phases V and VI

Streetscape Program – ADA Sidewalks and Corners Completed and Planned for Phases V and VI

Streets/Sidewalks Proposed for Improvement in Phase VI

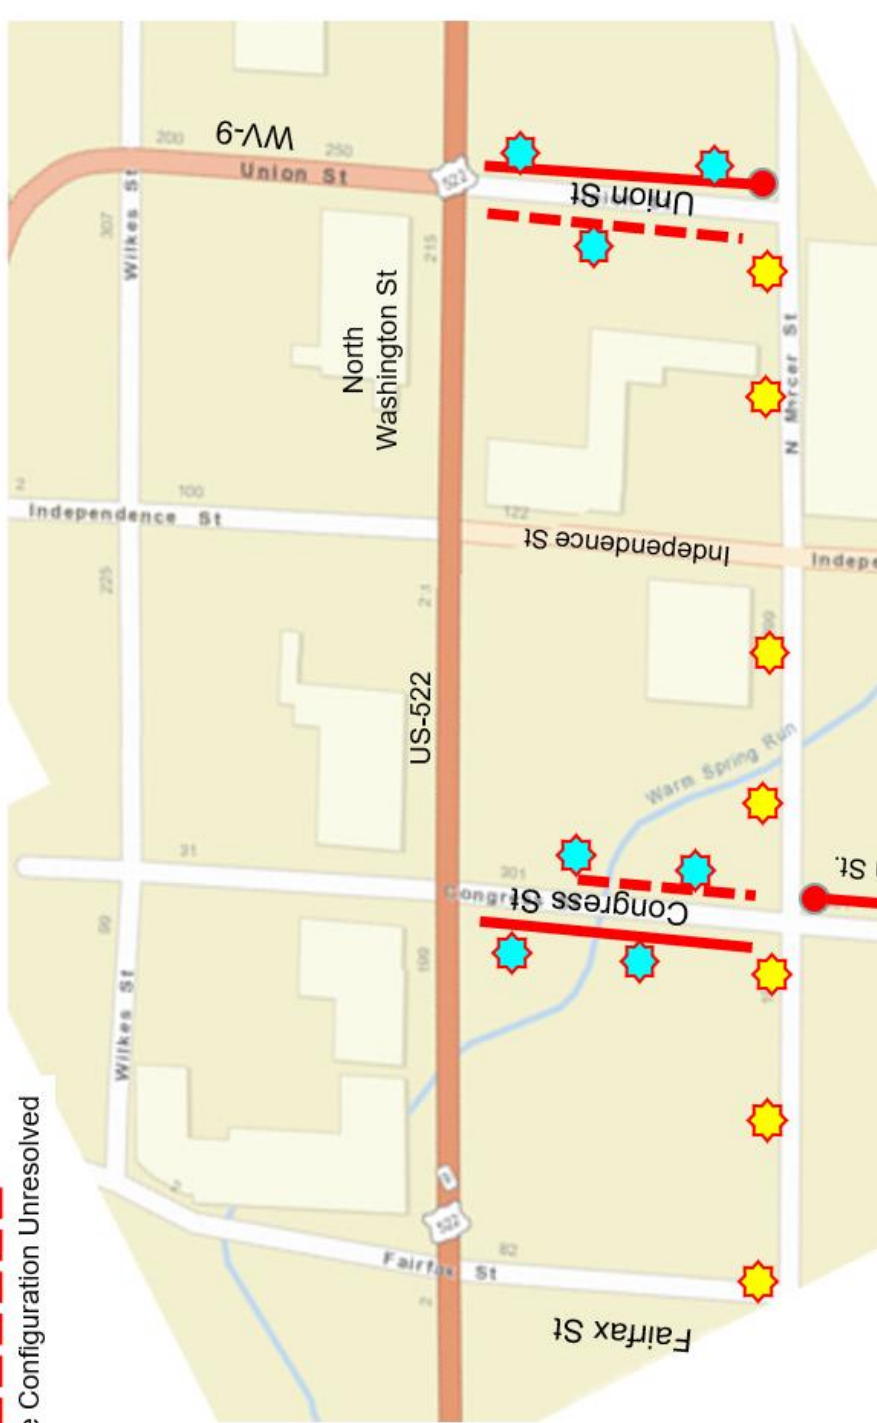
Streetscape Program – ADA Sidewalks and Corners Planned for Phase VI

Dashed Line – Phase VI

Future Configuration Unresolved

Seven new Streetlights on Mercer St.

Seven new Streetlights on Congress & Union Streets

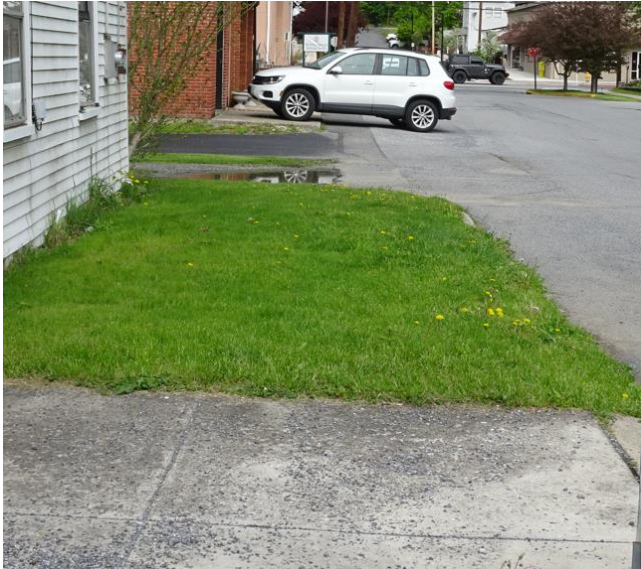
Congress St

South Side looking West between Warm Springs Run bridge and Mercer St. No ADA-compliant sidewalk. Need approx. 200 ft of new sidewalk and curb and ADA-compliant ramps to/from the bridge. Street drainage issues also in this area. Two new streetlights on this side of street.

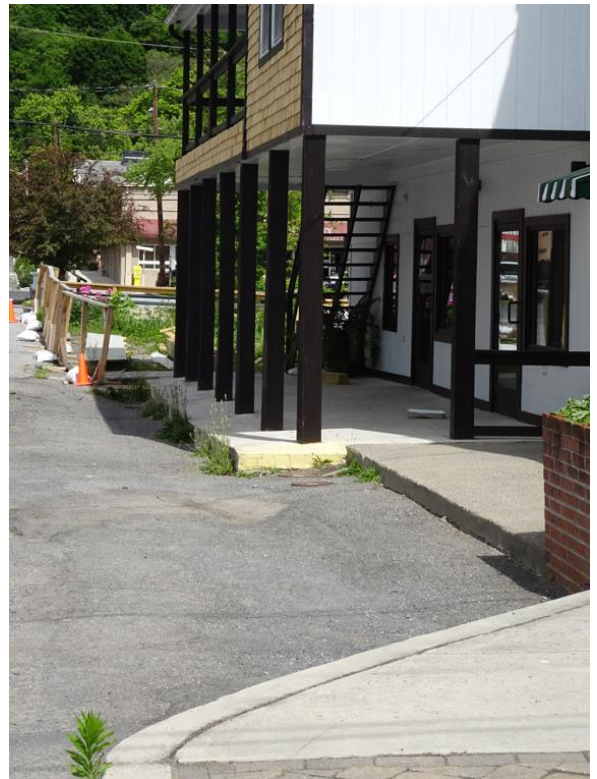
Congress St

North Side between Warm Springs Run bridge and Mercer St. No ADA-compliant sidewalk on this side. Drainage issues. Uncertain ADA-compliant bridge crossing to existing Library Sidewalk. Need approx. 110 ft. Two new streetlights on this side of street.

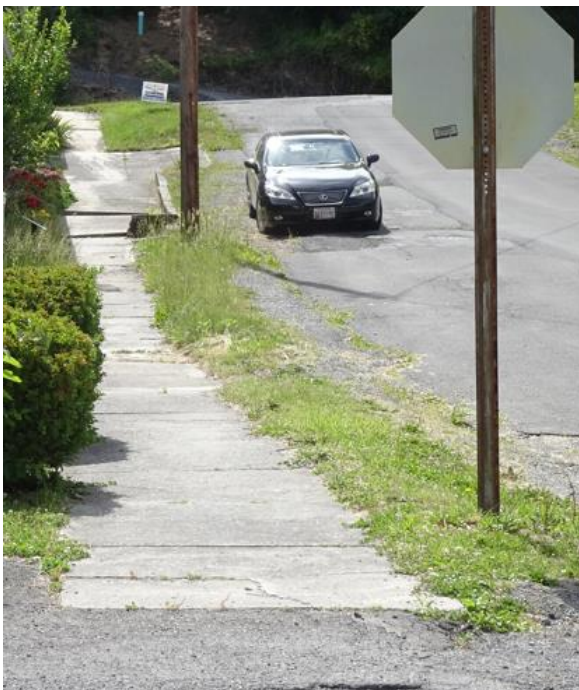
Congress St

North Side looking East between Mercer and Green Streets. Need curbing and ADA compliant sidewalk and corner ramps. Approx 180 ft of sidewalk and two simple concrete corner ramps needed.

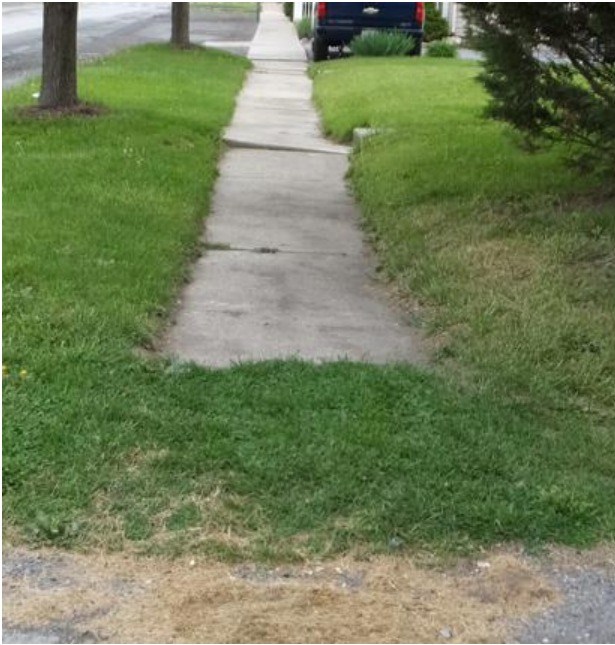
Union St

North Side looking West between Mercer and North Washington St (US-522). Sidewalk and ramp to Mercer St not ADA-compliant. Drainage issues near Mercer St. Need approx 105 ft of new sidewalk and curb and 1 ADA ramp between funeral home pull-in and Mercer St. Two new streetlights on this side of street.

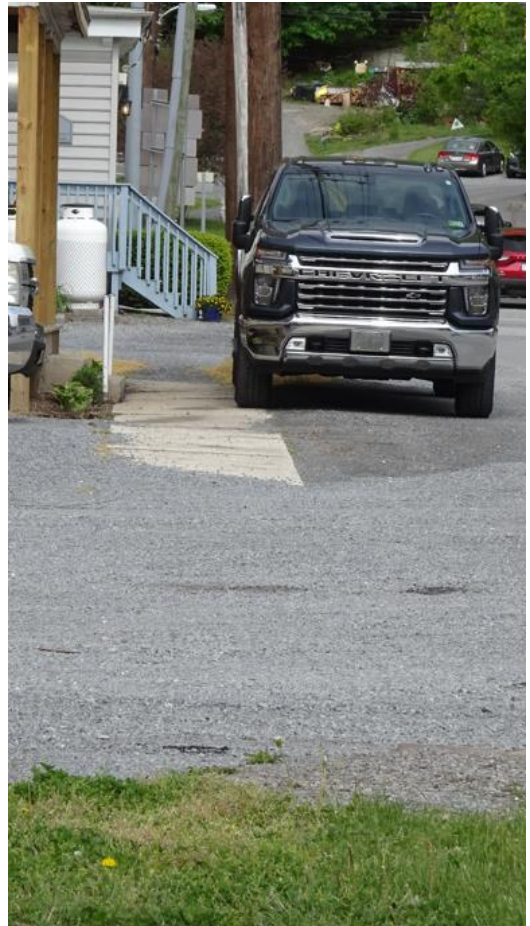
South Side looking West between Mercer and North Washington St (US-522). Need ADA-compliant sidewalk and curb and appropriate driveway and parking lot aprons. Need approx. 235 ft of new ADA compliant sidewalk and curb. Need connection of existing/new drains to the Run to reduce ponding in the Mercer St and Union St intersection. One streetlight on his side of street.

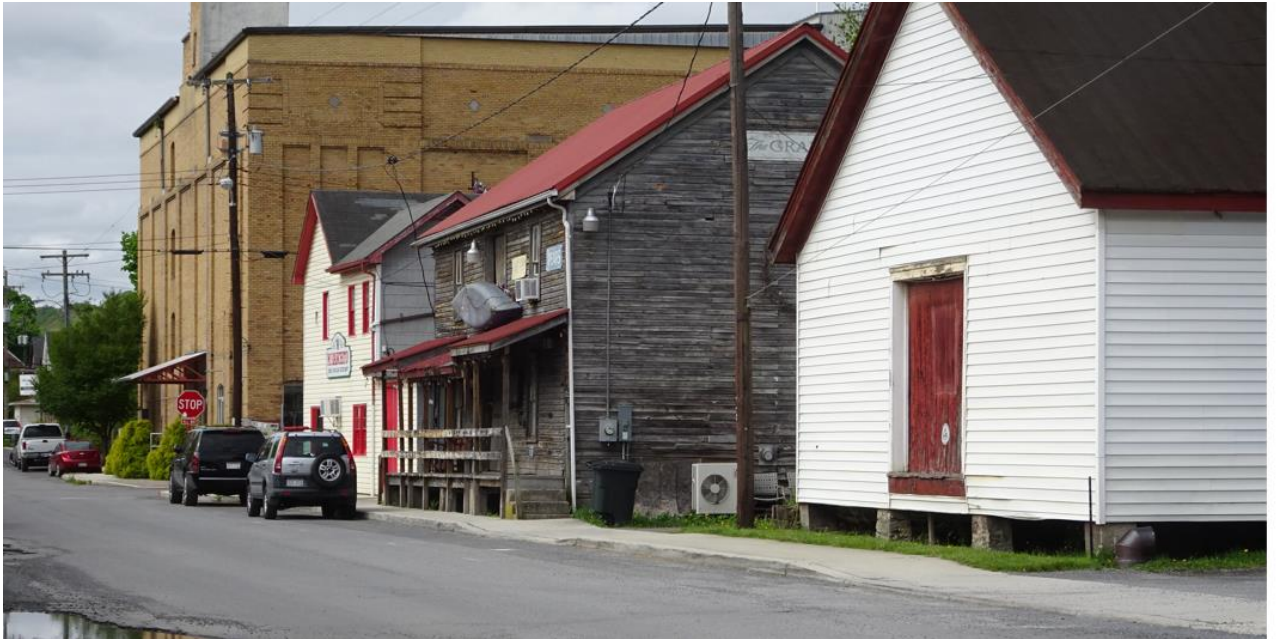
Mercer Street

West Side looking southwest between Union and Fairfax Streets. Need to complete streetlights. Conduit installed in Phase II. Need wiring from power enclosure in Library Parking lot or other TBD connection designed for Phase V to seven new streetlights along the west side of Mercer St. ADA-compliant sidewalk and corner ramps are in place along these blocks of Mercer St. Total wiring run: approx. 950 ft along sidewalk – conduit is supposed to be already installed under the current sidewalk.
